NASA CR-121193
APS-5404-R
Volume II

SMALL, HIGH-PRESSURE RATIO COMPRESSOR MECHANICAL ACCEPTANCE TEST

AIRESEARCH MANUFACTURING COMPANY OF ARIZONA

NASA Lewis Research Center
Contract NAS3-14306

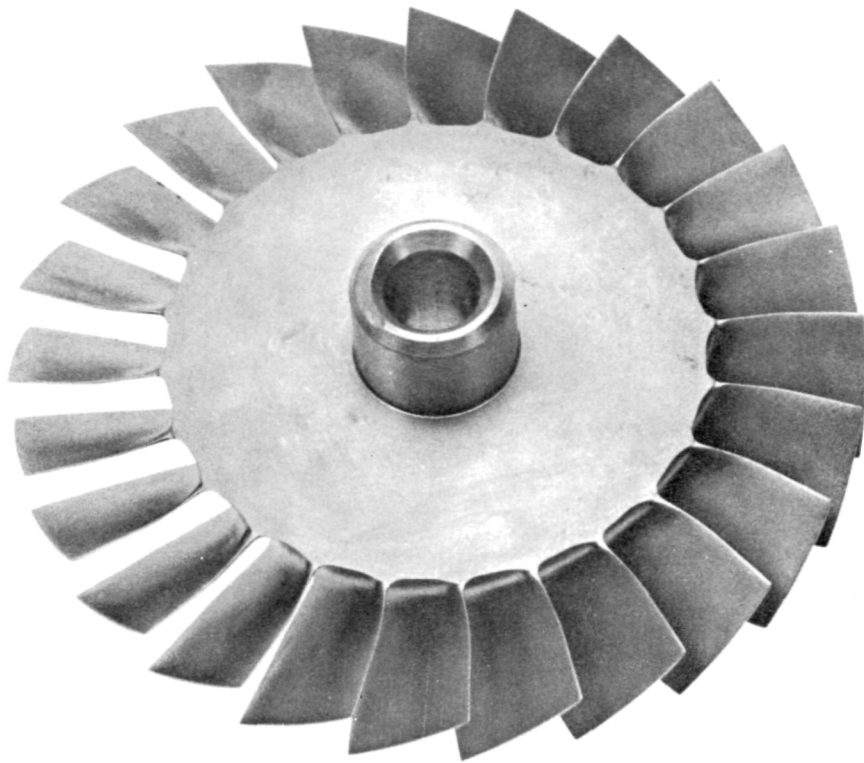
Figure 4. Front View of Inducer SKP25657-1.

Several parts required rework prior to the first build. Inspection revealed that the diffuser assembly, SKP25710-1, required inside diameter remachining to clear the impeller tip diameter; the compressor shroud, SKP25668-1, had an incorrectly machined contour; the inlet bellmouth, SKP25708-1, was too short for accurate calibration and required a neck extension; and the inlet housing, SKP25666-1, was inadequately machined to achieve the required stacking dimensions. All hardware was corrected for the first build by October, 1971. Photographs of the impeller and inducer are shown in figures 4 through 8.

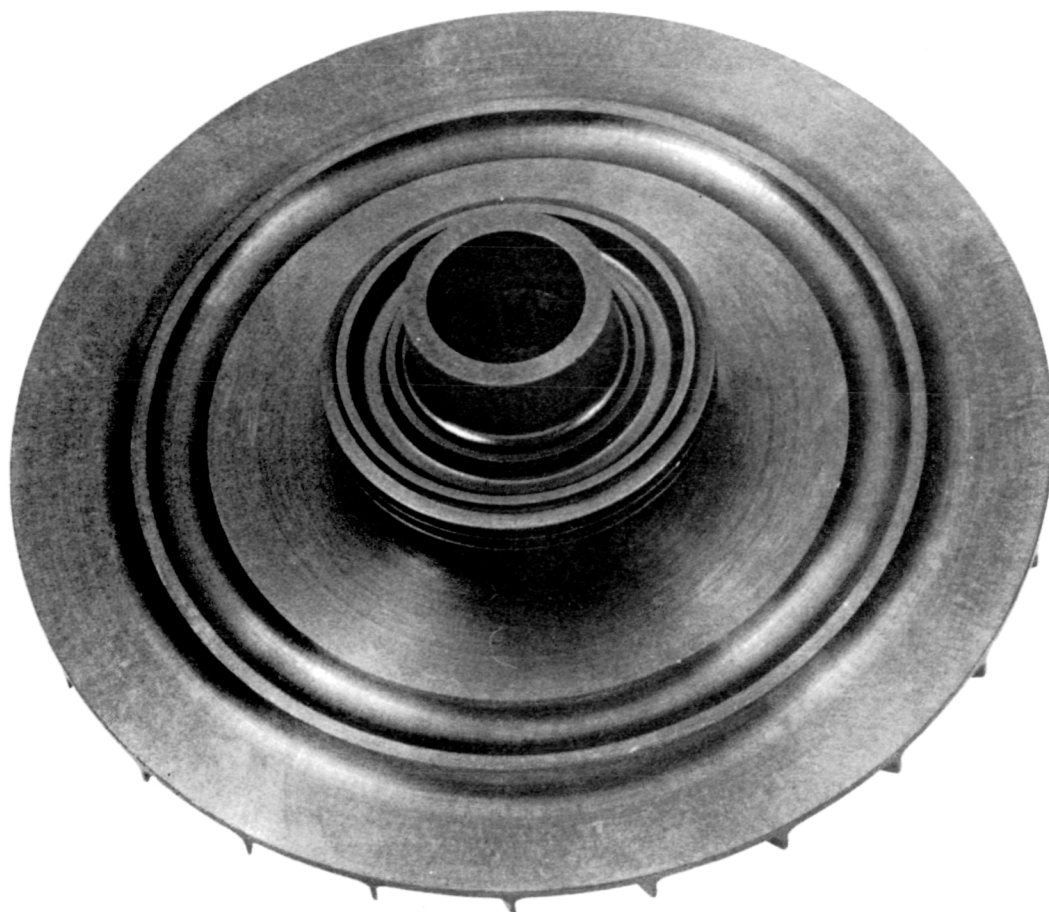
Figure 5. Back View of Inducer SKP25657-1.

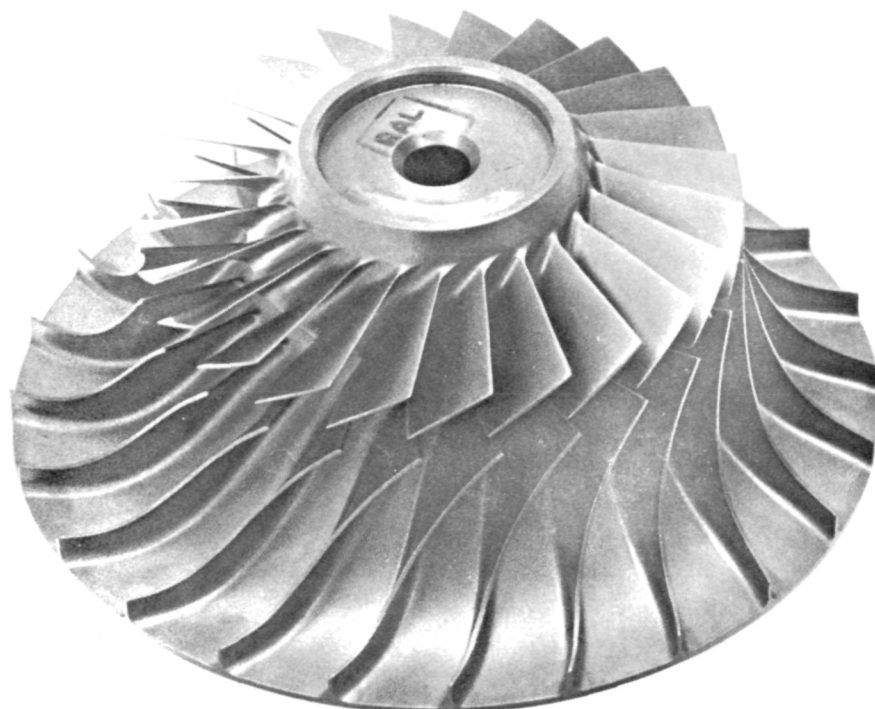
Figure 7. Front View of Impeller SKP25658-1.

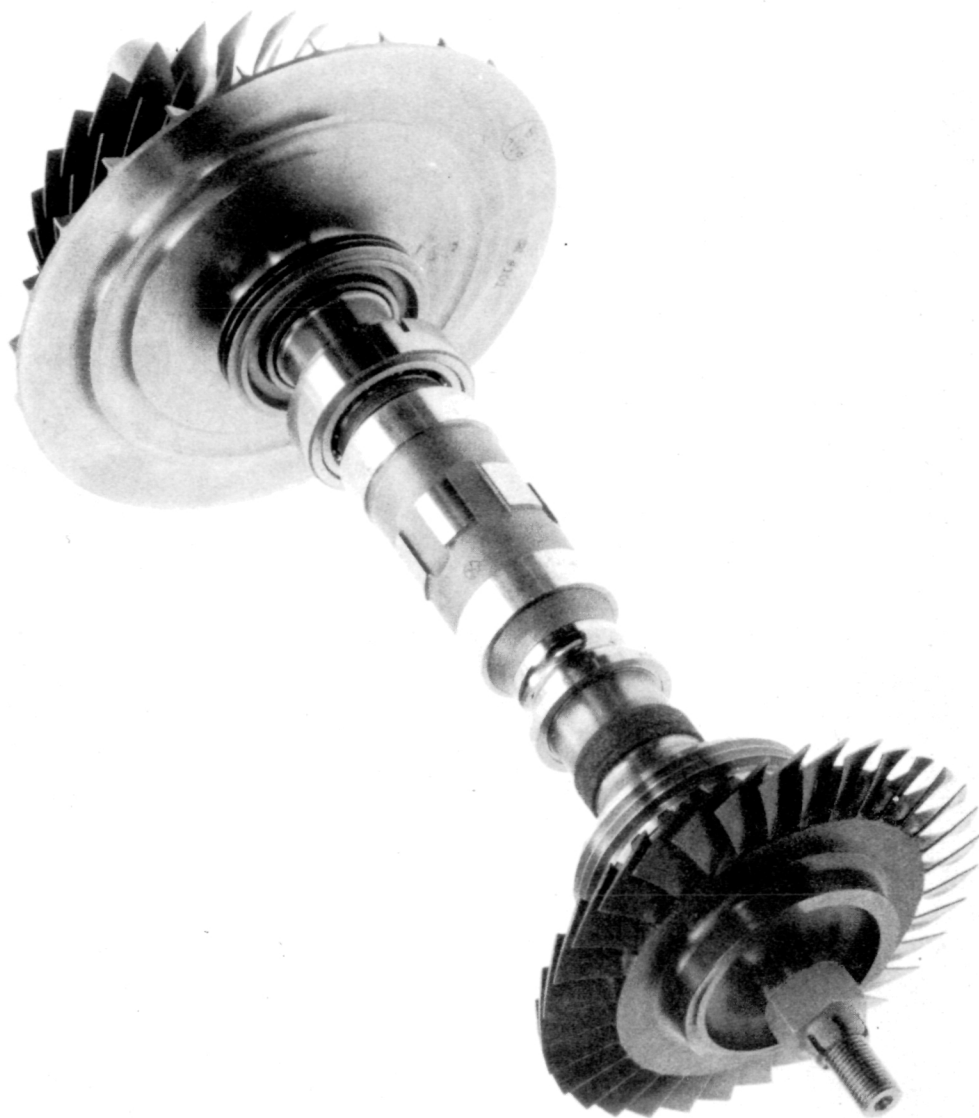
Figure 8. Inducer and Impeller Assembly.

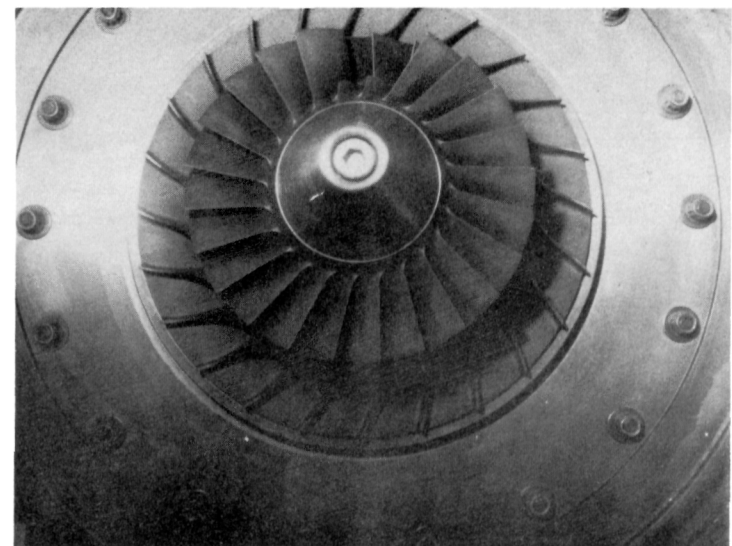
Examination of the rig revealed that two adjacent blades on the SKP25657-1 inducer were missing. An investigation was undertaken to determine the cause of inducer failure. The damaged inducer and other damaged hardware are shown in figures 18 through 24.

Figure 18. NASA 6:1 Compressor Test Rig
SKP25657-1 Inducer Failure.

As described in Appendix I, hand finish marks were implicated in the inducer blade failure. Electropolishing the inducer to remove surface hand finish marks was undertaken to allow testing to proceed with an impeller-inducer configuration prior to receipt of the new inducers. This would determine whether the rig was mechanically sound in the design configuration. After polishing and inspection, concurrence to proceed was obtained from the AiResearch Engineering Mechanics Group and the NASA-Lewis Project Manager.

Replacement inducers, SKP25657-1, were ordered because electropolishing to remove hand finish marks would alter blade profiles sufficiently to make them unacceptable.

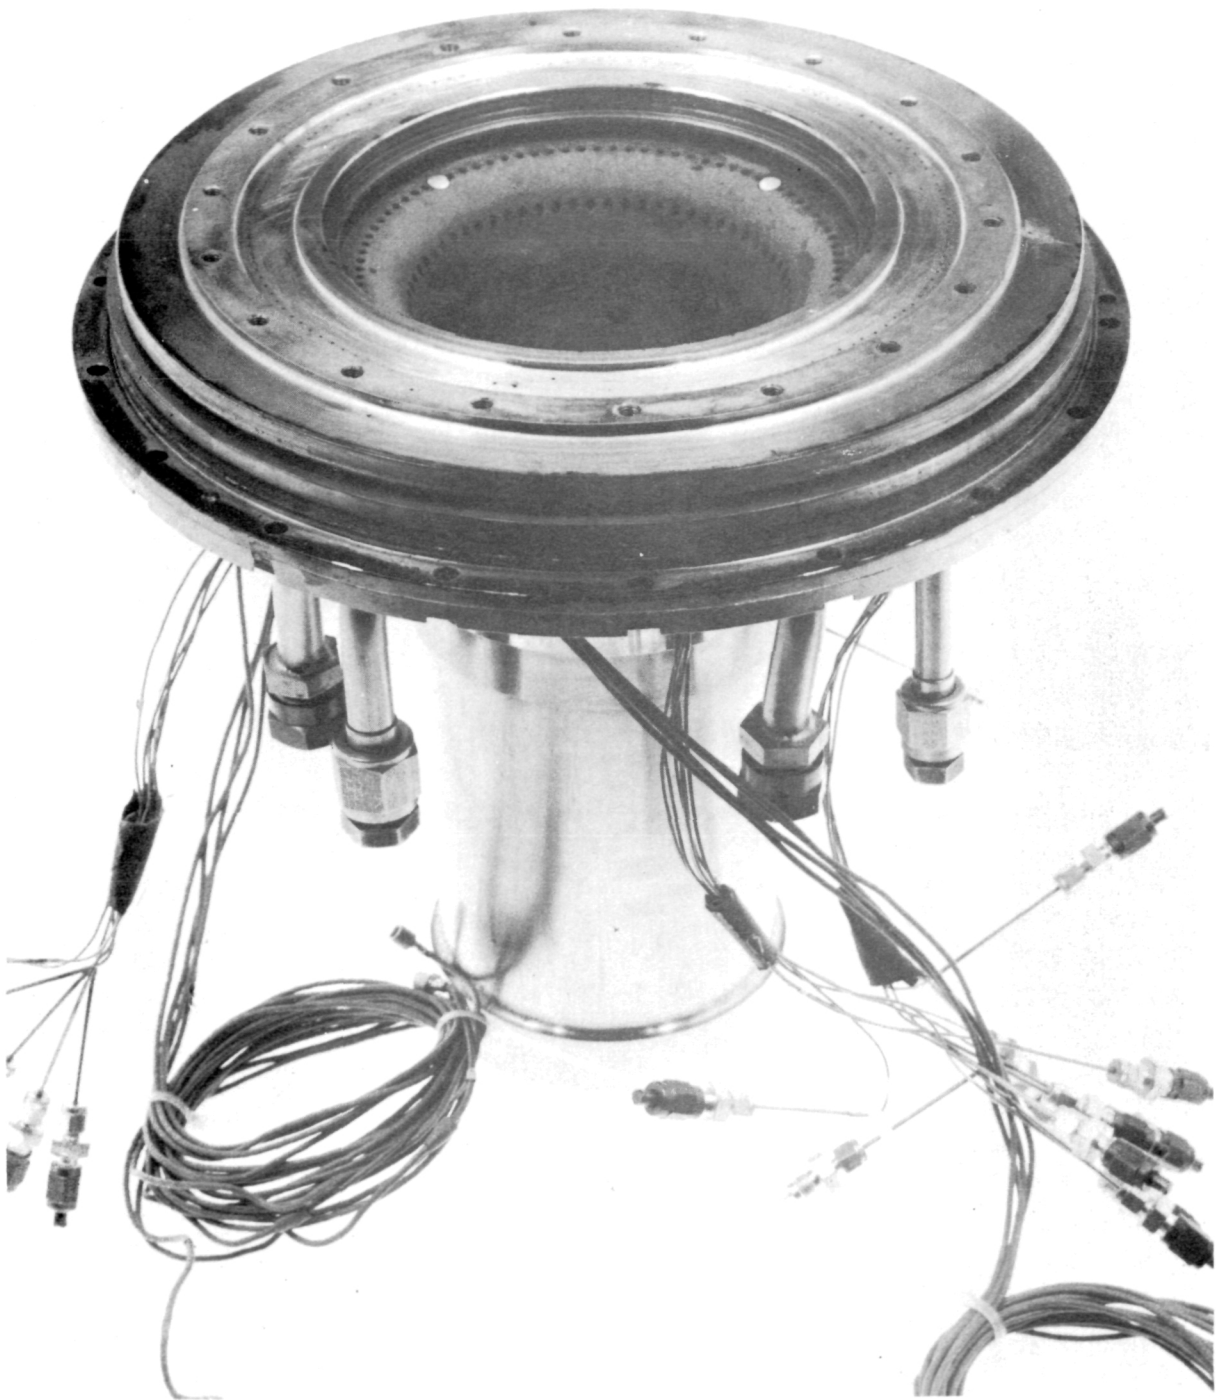
Disassembly of the test rig revealed that the front side of the turbine wheel had rubbed the nozzle housing. Figures 28 through 42 show test rig parts. The inducer and impeller were zygloed and the turbine wheel was magnafluxed. No indications of distress were observed. All other hardware appeared in excellent condition except the strain gage had a stray ground. The part was sent to instrumentation and repaired.

Figure 28. Shroud Assembly, NASA 6:1 Compressor Test Rig, 120-Percent Speed Test.

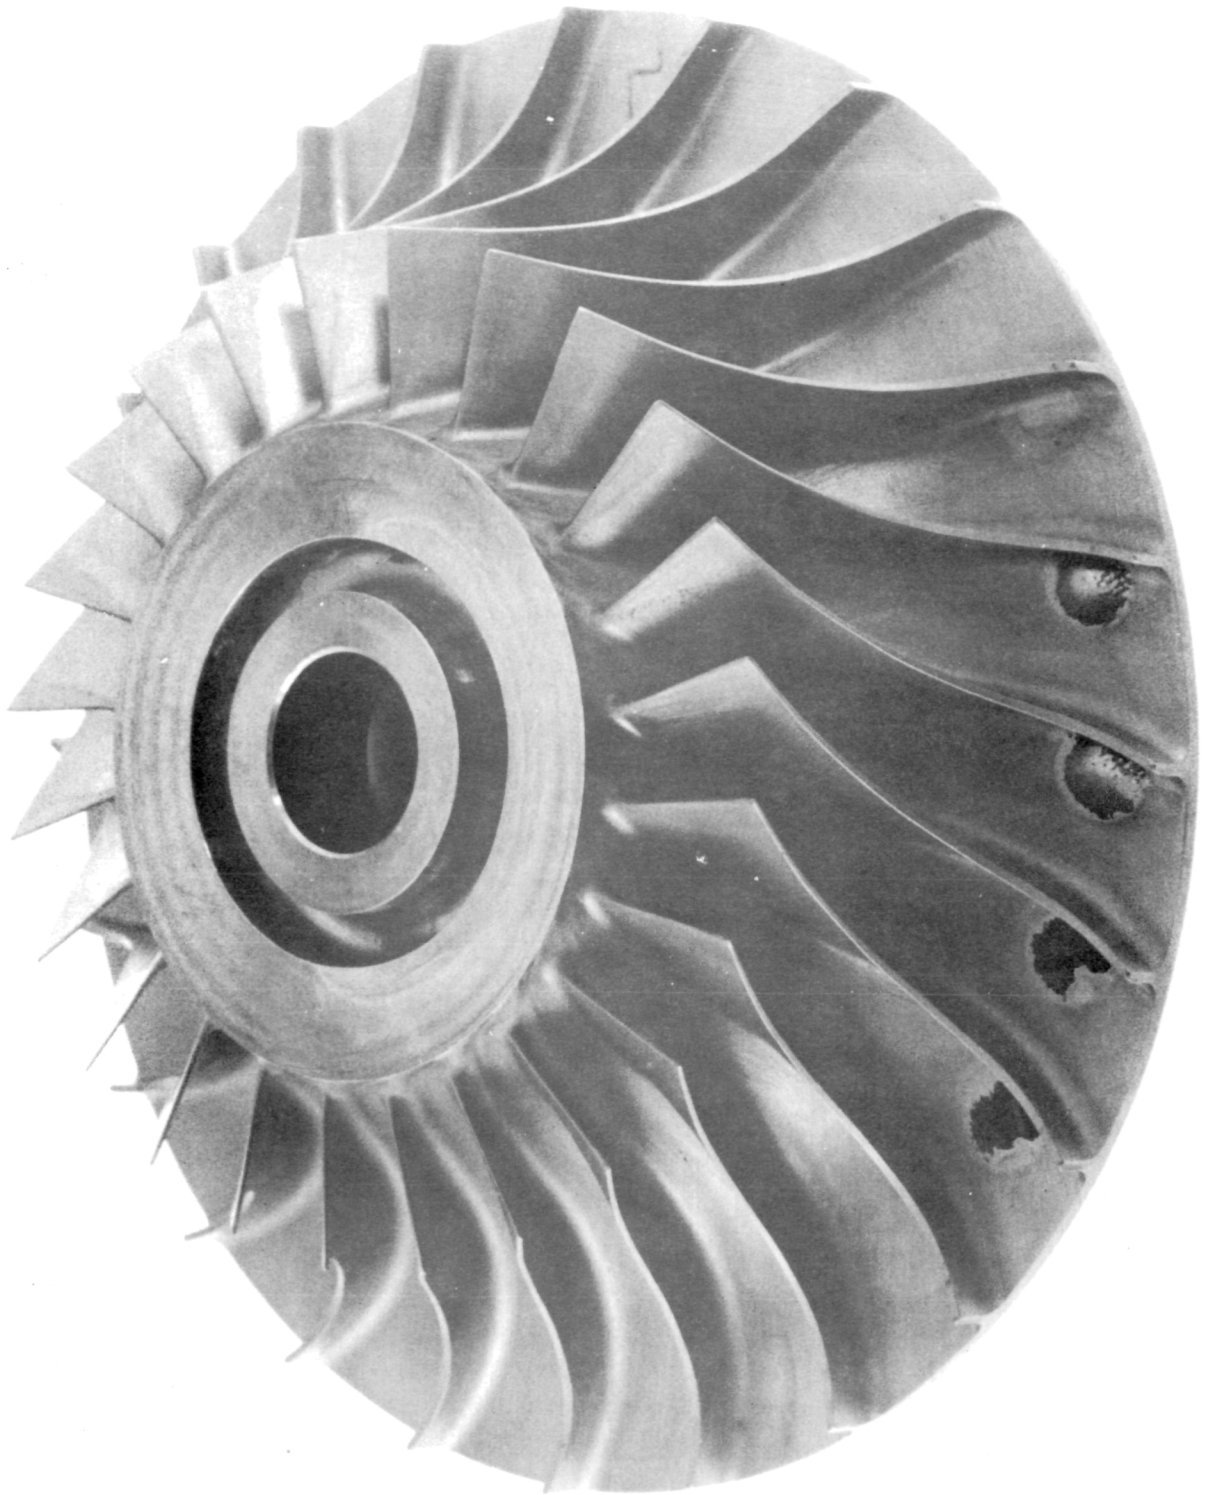
Figure 30. Impeller SKP25658-1, NASA 6:1 Compressor Test Rig, 120-Percent Speed Test.

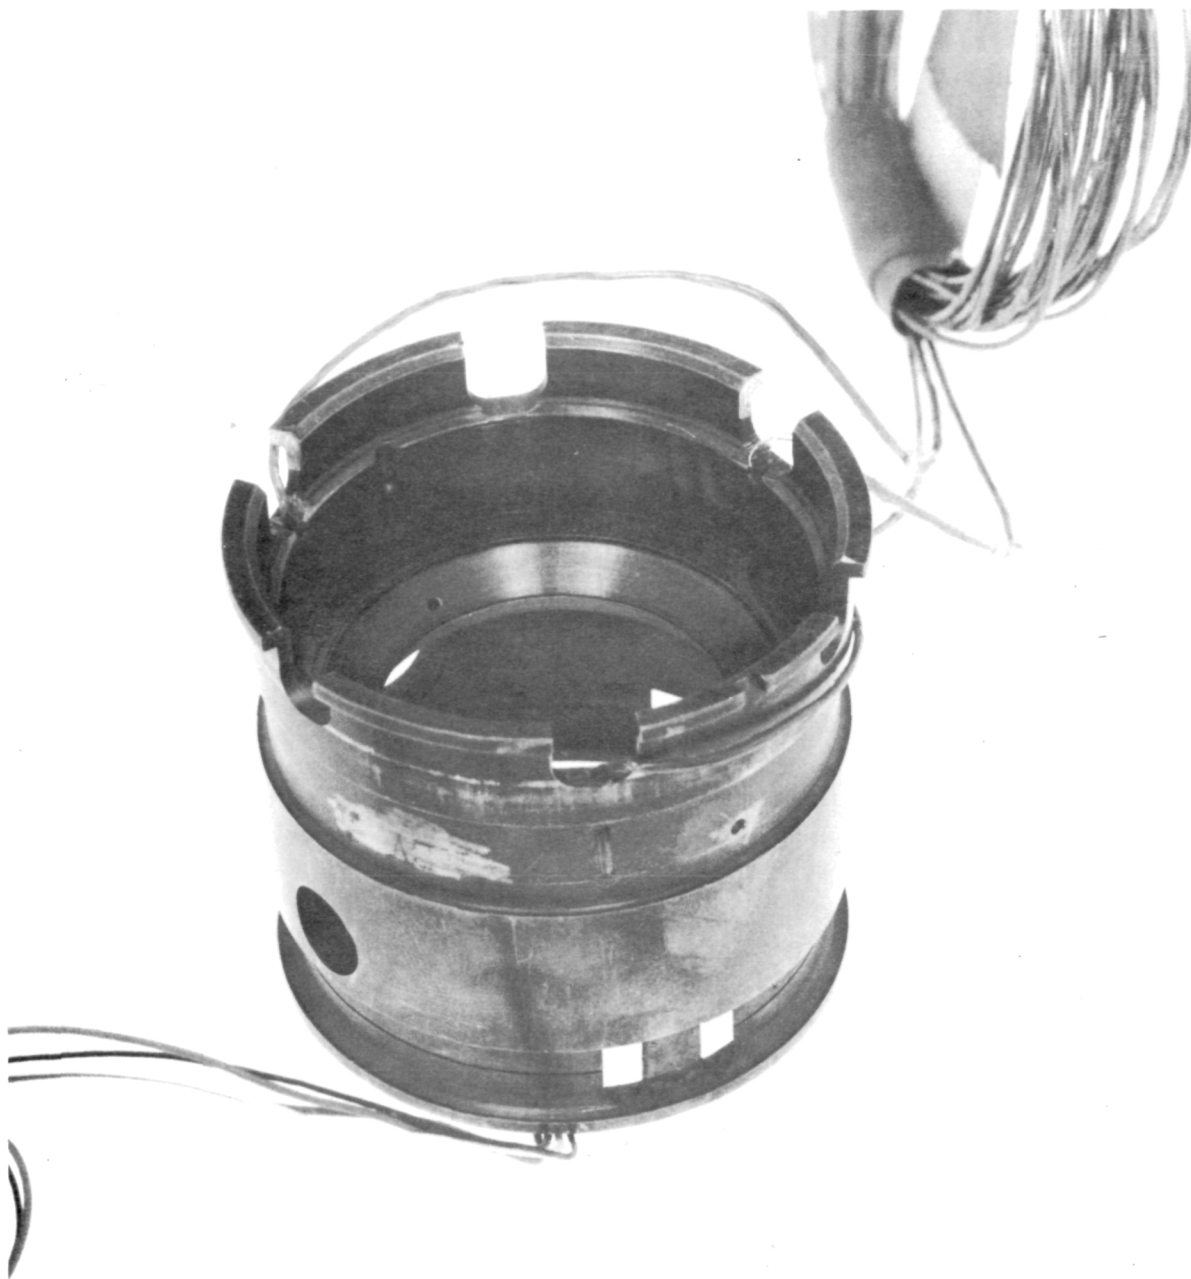
Figure 32. Retainer SKP25643-1, NASA 6:1 Compressor Test Rig, 120-Percent Speed Test.

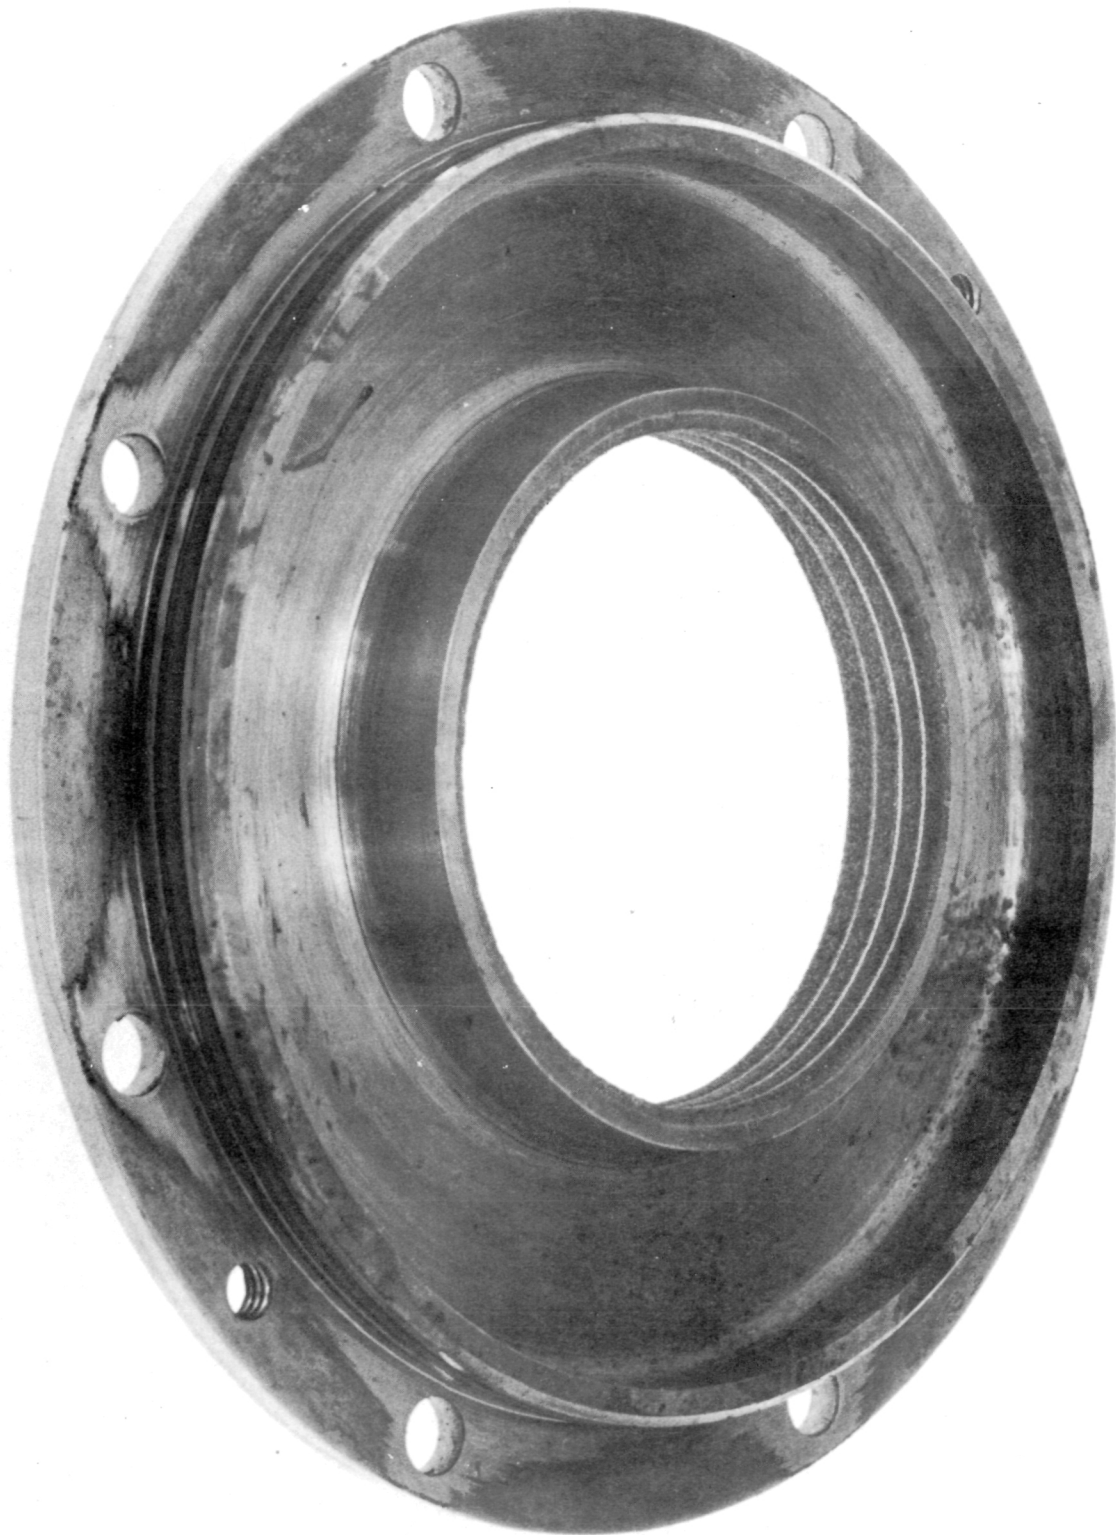
Figure 34. Seal Plate 25669-1, NASA 6:1 Compressor Test Rig, 120-Percent Speed Test.

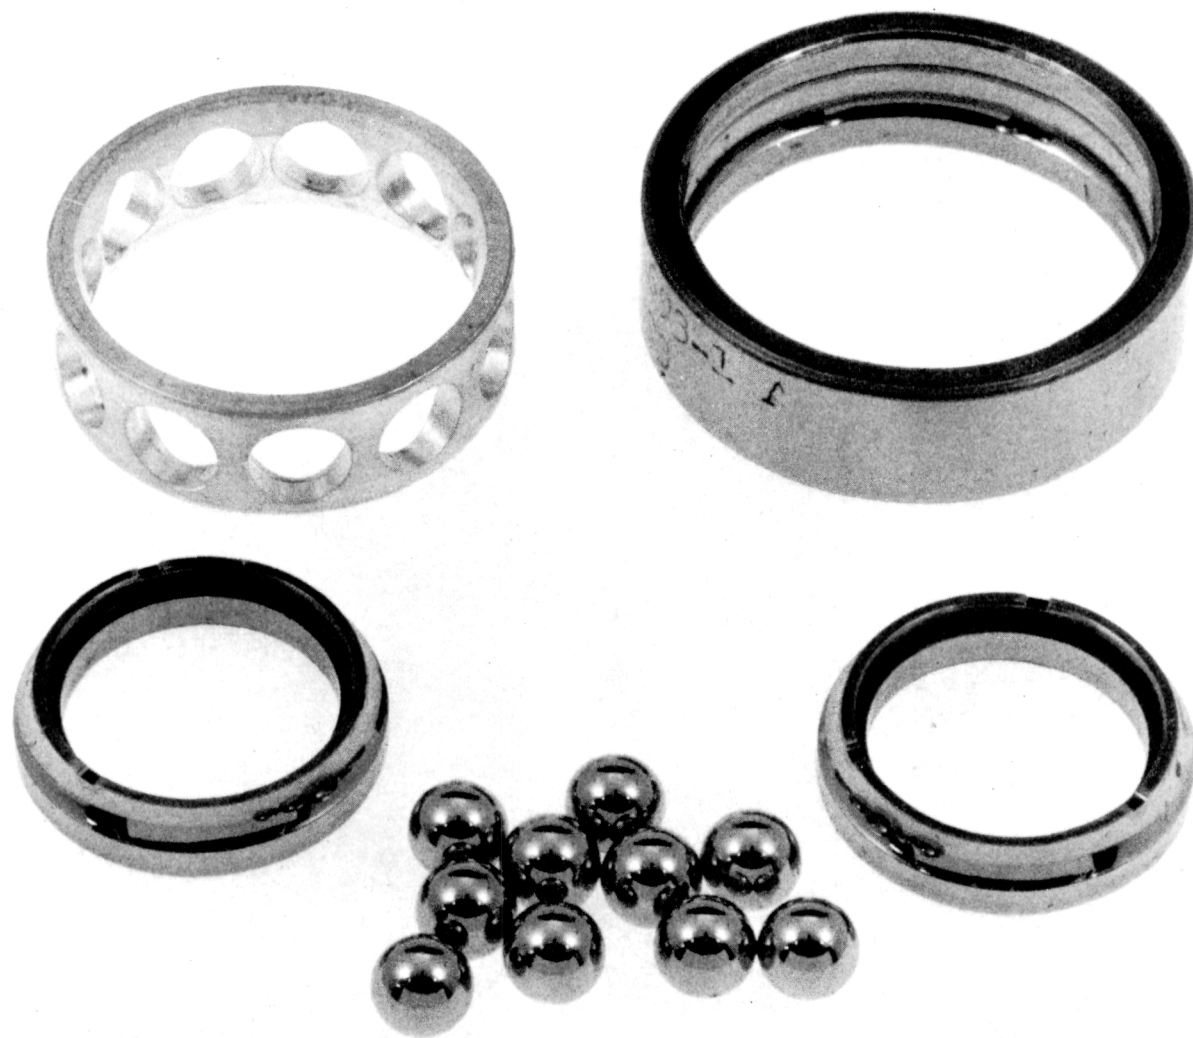
Figure 37. Bearing 976693-1, NASA 6:1 Compressor Test Rig, 120-Percent Speed Test.

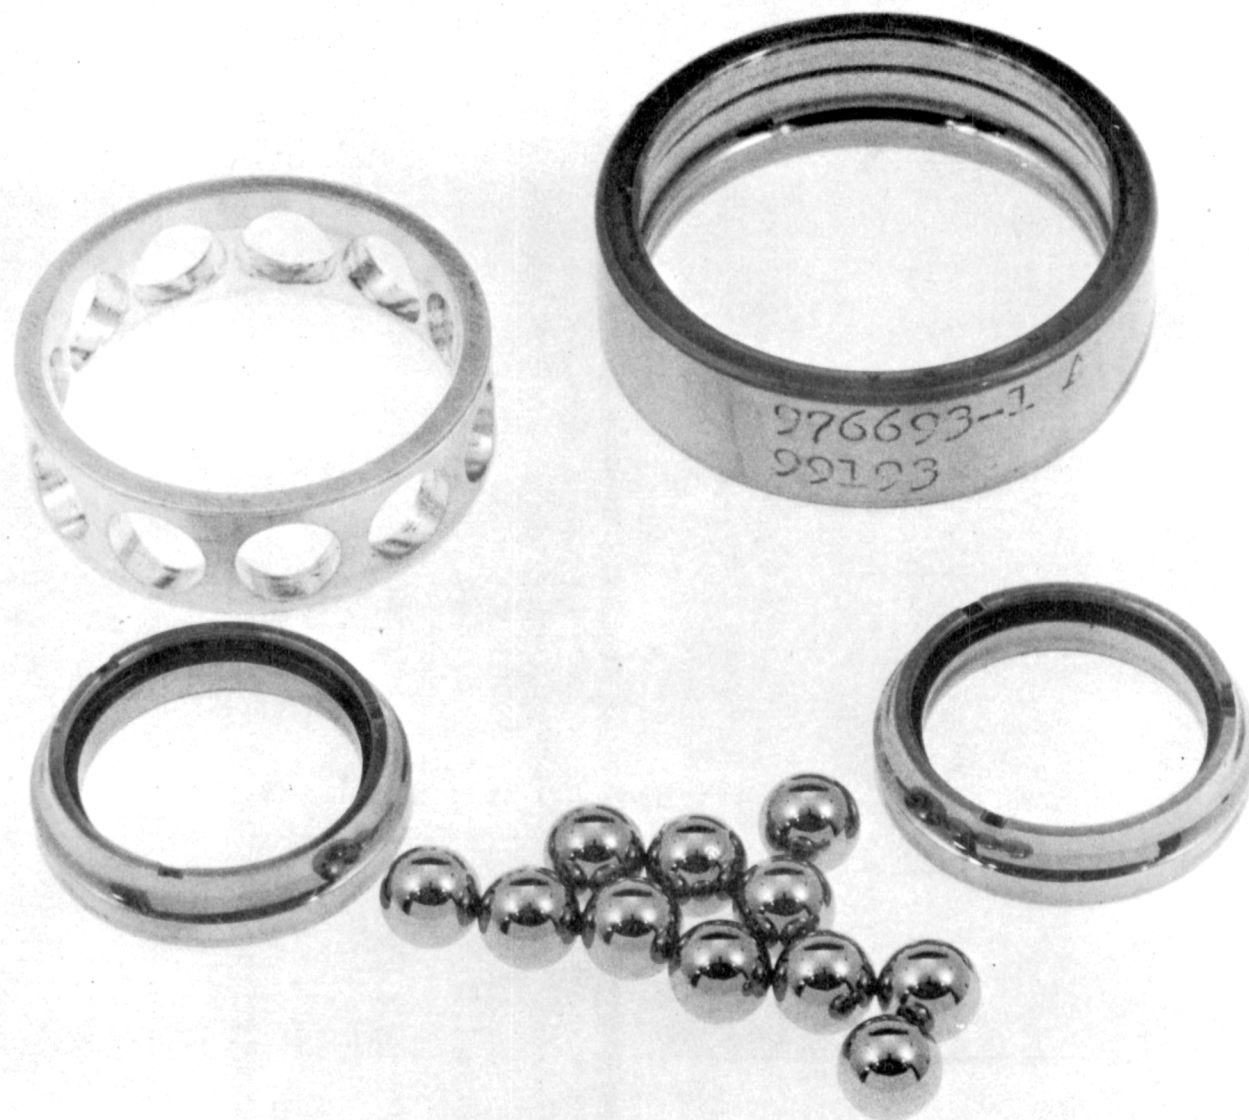
Figure 38. Bearing 976693-1, NASA 6:1 Compressor Test Rig, 120-Percent Speed Test.

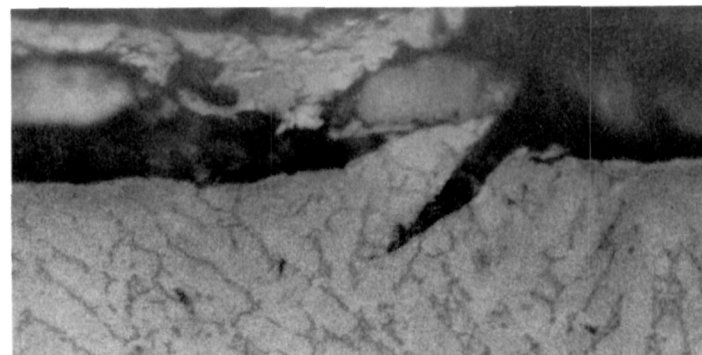
FIGURE 3 - SUCTION SURFACE OF VANE AT TRAILING EDGE. PHOTO ON RIGHT IS JUST ABOVE CRACK (UNETCHED AREAS ARE NICKEL PLATE USED TO RETAIN SPECIMEN EDGE). PLANE OF SECTION PERPENDICULAR TO AXIS OF WHEEL.
ETCHED
